Project: (D214038) NYSTA Term Agreement, Design Support Services, Rehabilitation of the Fairport Spillway Wall, Buffalo Division

Location: Village of Fairport, Monroe County, NY

Client: New York State Thruway Authority / New York State Canal Corporation

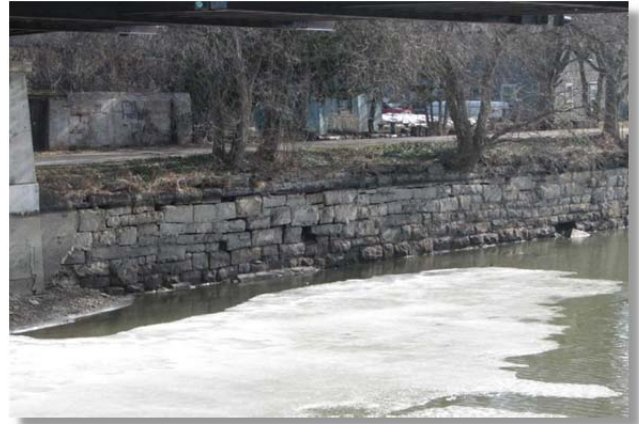
Deteriorating Canal Wall

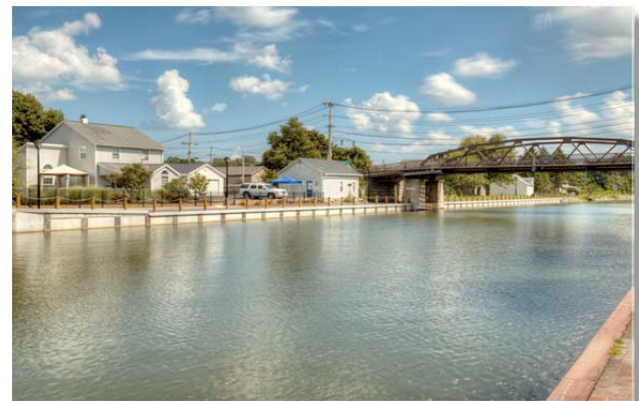
*Top: Rehabilitated Canal Wall
Bottom: Pedestrian Trailway*

Prudent developed preliminary plans and drawings, specifications, construction estimate for a wall design alternative, and an H-pile with precast panel lagging. Details for the proposed wall rehabilitation were designed and

developed, including the completion of typical wall sections and structural repair details; material quantity tables and reinforcing bar lists; and construction cost estimates.
