**Project:** DASNY Term Contract Renewal,  
Kingdom Dam

**Location:** Elizabethtown, New York

**Client:** Dormitory Authority of the State of New York

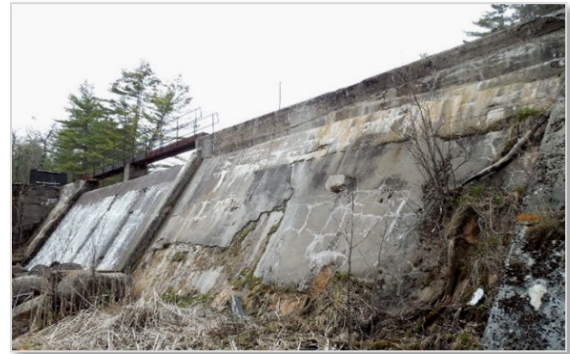
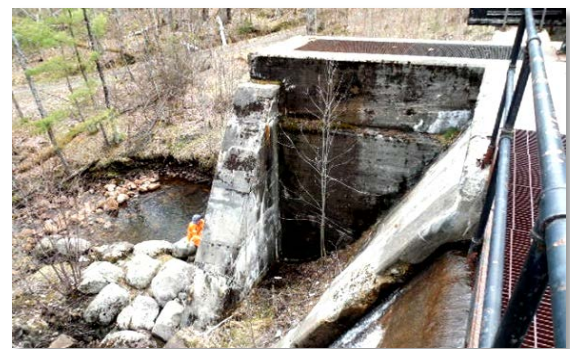
*Kingdom Dam*

Kingdom Dam, a concrete gravity structure, was built in 1911 and sits at the north end of Lincoln Pond. Prudent conducted survey and field inspections of the outlet structure, and developed the design of remedial measures for the dam and related structures. Prudent's survey team documented the topography at the dam, including terrain upstream and downstream of the structure; obtained locations and elevations of structures/homes near or downstream of the dam; photo-documented structures and homes in proximity of the downstream area; collected survey points at the bridge and along selected cross sections on the waterway and at the dam; and established vertical and horizontal control at the dam site.

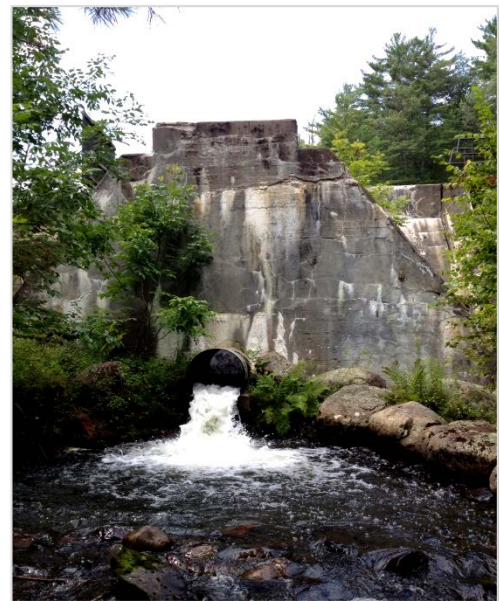
*Kingdom Dam Outlet*
